ASPHALT TECHNOLOGIES, INC.

TEST & EVALUATION REPORT Shingle Rejuvenator Benchmark Life-Cycle Study

July 6, 2023

Report For: Greener Shingles Rejuvenator
Saskatchewan, Canada

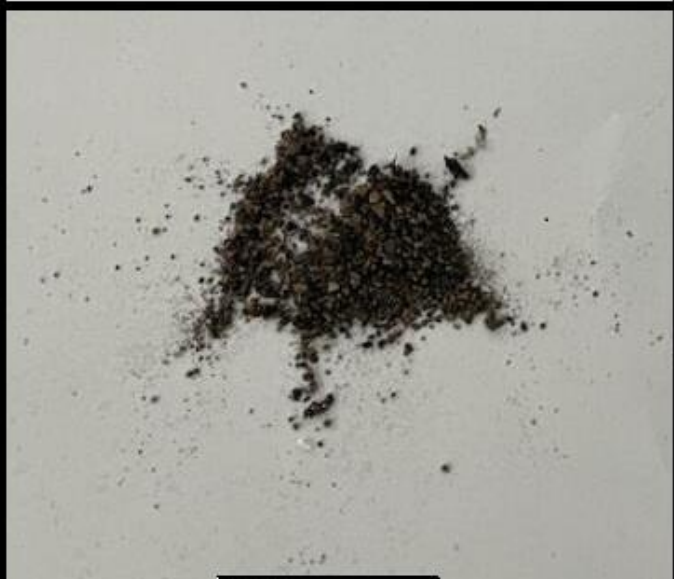
Greener Shingles Rejuvenator	Un-Treated Shingles

<p data-bbox="363 1081 581 1136">0.70 grams</p>

Granules and particulate washed from the roof decks after 1500 hours of exposure. Particles have been filtered from the accompanying runoff water and dried for quantification.

- After 1,500 hours of exposure the mass of the collected particulate from the un-treated shingles was 4.08g compared to 0.70g for the Greener Shingles' rejuvenator.

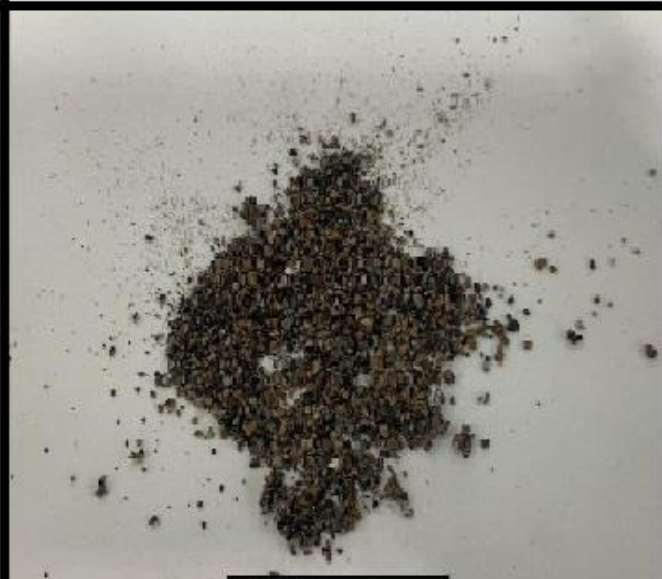
<p data-bbox="1040 1081 1258 1136">4.08 grams</p>
